June 29, 2007

Volume 15, Issue 1

A FOCUS ON SAFETY

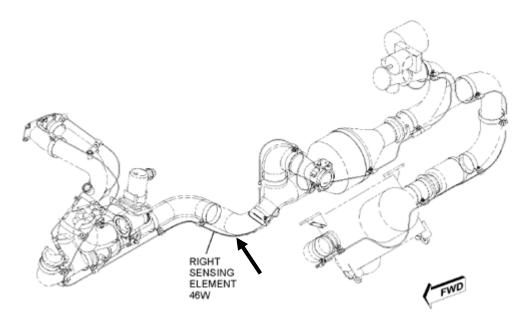
Gulfstream Customer Support was recently contacted stating that the crew reported that a few minutes after APU air was selected "On" the red "R Bleed Air Leak" message illuminated. The crew turned off the APU air but the message remained on so they shut down the APU and all power. Using only the aircraft batteries they noted that the message was still illuminated

The Right Bleed Air Detection and APU Bleed Air Detection boxes were then swapped with the message still illuminated. The 132W1 plug was disconnected from the right Bleed Air Detection Box and while checking the pins in the plug it was found that the loop was shorted to ground on pins 10 and 11. A close examination of the loop revealed that the sensing loop (see graphic) was kinked, next to the right engine fire box where it turns 180 degrees back across both right engine bleed off-takes. Repositioning the sense loop removed the kink, eliminated the short, and extinguished the message.

The aircraft was relocated back to a maintenance facility where the sensing element loop (P/N 35660-2-310) was replaced restoring normal operation.

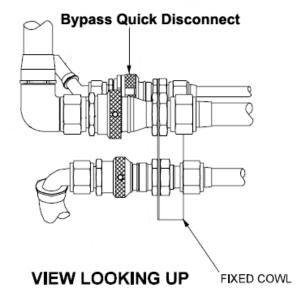
Bypass Quick Disconnect at Fixed Cowl

A GIV flight crew noticed hydraulic fluid dripping out of a lower engine cowling. A closer inspection by maintenance technicians found the hydraulic pump case leaking at the mating area. A replacement hydraulic pump was installed.

Maintenance personnel mentioned that this is the second hydraulic pump failure on this engine in a year. The previous pump failed in the same manner. Based on this information, it was decided to look at the pump bypass check valve and the security of the quick disconnect. The check valve was found to be okay. The quick disconnect at the fixed cowl was found loose and not connected. A replacement disconnect was installed, and both return filters were replaced.

In the event of a hydraulic pump found leaking at the pump case mating surface, the engine pump case drain plumbing should be thoroughly checked for anything that could allow pump case pressure to build up, causing the leaks.

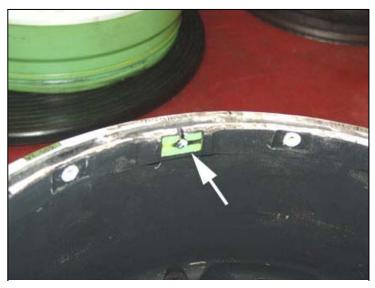
It was recently brought to the attention of the main wheel manufacturer, Dunlop, that specific instances have occurred where cracks have been found in the hub assemblies around the drive bar bolt holes of the GIV and GV Main Wheels (GIV Wheel Dunlop P/N: AHA2063, GAC P/N: 1159SCL403-5; GV

Area on wheel where an old style spacer was installed. Area with black strip is where cracking can occur.

Dunlop recommends replacing these units in each main wheel (8 spacers per wheel) when they are in for their next visit at a maintenance facility. If this Service Bulletin is complied with and the new spacers are ordered through Gulfstream, they will be issued at no charge under Dunlop Service Bulletins AHA2063-32-1355 (GIV) and AHA2114- 32-1356 (GV). It is important to note that in order to be free at no charge, the customer must provide the serial number of each wheel that is having its spacers replaced.

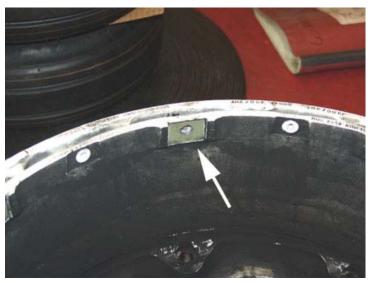
It was determined that a different shaped spacer (one that has full contact with the mating surface of the hub assembly) can decrease the possibility of cracks in this area. manufacturer (Dunlop) developed a Service Bulletin to address this issue. The original part number of this spacer was AHO91112, and part ofthe newly-shaped DAC10580-01. MKLMAR43 is the part number for the MOD kit that contains 8 of the new spacers.

Area on wheel where the new style spacer is installed.
