INCIDENT

Aircraft Type and Registration:	Falcon 2000, CS-DFE	
No & Type of Engines:	2 CFE 738-1-1B turbofan engines	
Year of Manufacture:	2003	
Date & Time (UTC):	11 November 2009 at 1259 hrs	
Location:	Biggin Hill Airport, Kent	
Type of Flight:	Maintenance	
Persons on Board:	Crew - 3	Passengers - 3
Injuries:	Crew - None	Passengers - None
Nature of Damage:	Fire damage to tyres, fuselage, landing gear and wing	
Commander's Licence:	Airline Transport Pilot's Licence	
Commander's Age:	37 years	
Commander's Flying Experience:	4,152 hours (of which 575 were on type) Last 90 days - 30 hours Last 28 days - 5 hours	
Information Source:	AAIB Field Investigation

Synopsis

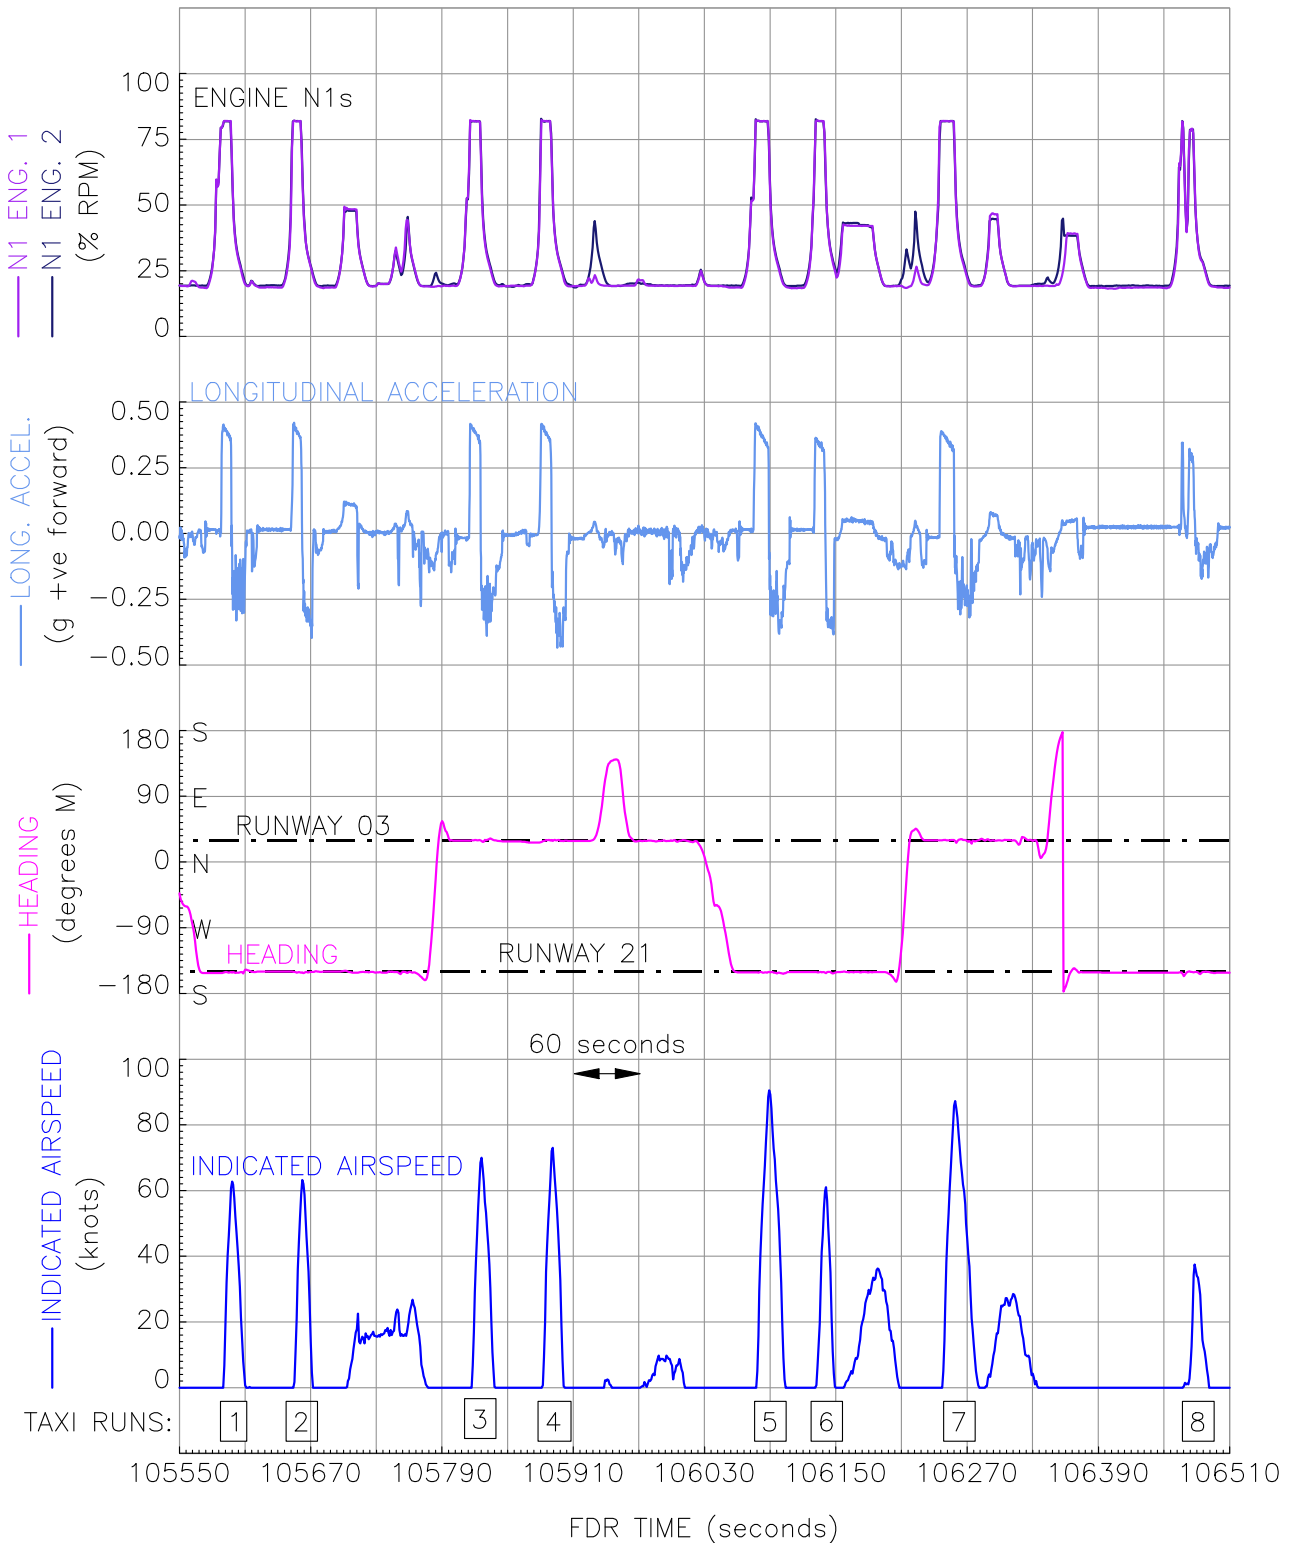
Figure 2
Salient FDR parameters from CS-DFE of high-speed taxi runs

The salient FDR parameters are presented at Figure 2 and show that in total, eight high-speed taxi runs were completed over a period of just under 16 minutes. The first seven runs achieved speeds of between 60 kt and 90 kt. The final run was aborted at just over 35 kt¹ when

The duration of each of the runs was between 20 and 25 seconds. A number of runs were conducted one after the other on the same runway, with a gap of about 45 seconds between runs. Others required a change of runway which took between 90 and 200 seconds to complete.

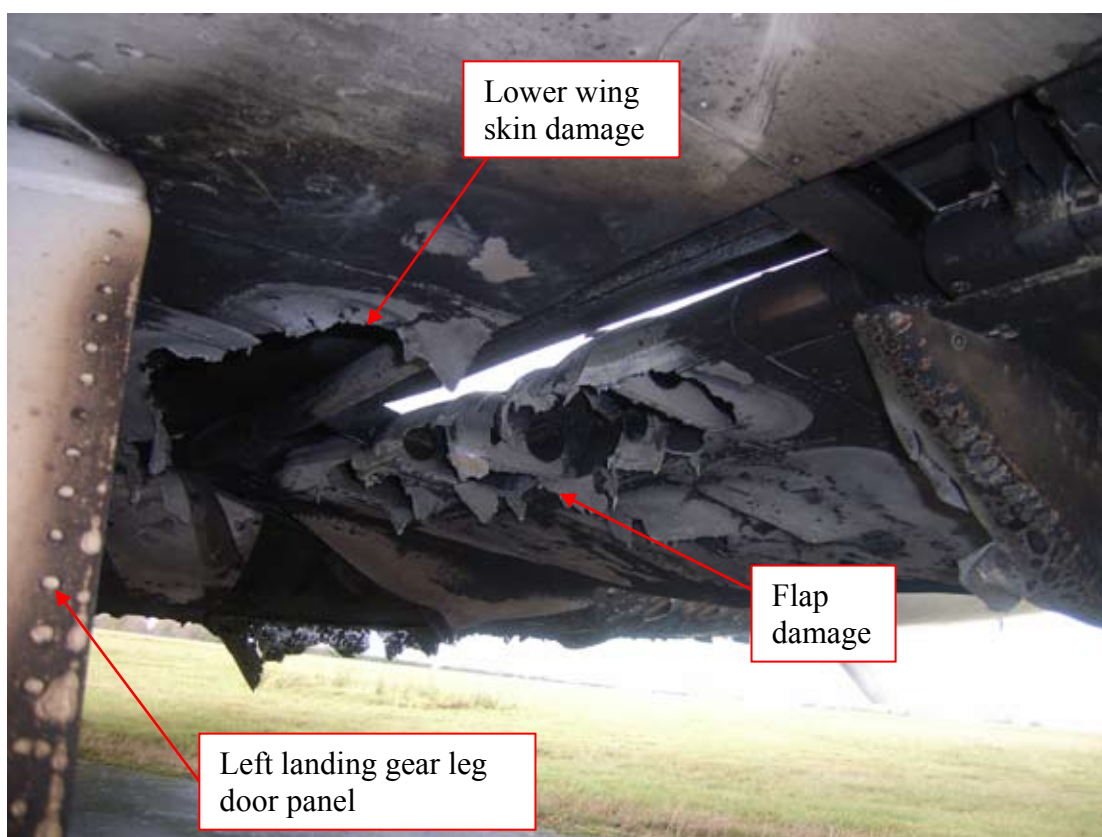
Figure 4

An initial inspection of the aircraft was carried out on the taxiway which confirmed severe fire damage. A significant section of the lower skin of the left wing, rear of the landing gear bay, was burnt away, as was the

lower skin of the adjacent flap, which had been partially deployed at the time (Figure 4). The landing gear bay within the wing was heavily sooted with extensive heat damage evident to the upper wing skin and the electrical wiring looms running along the rear of the wing. The fuselage panels adjacent to the left MLG bay were severely heat damaged and the whole of the fuselage, rear of the wings, was heavily sooted. The number two hydraulic system reservoir level indicator showed that the system contained no hydraulic fluid; the number one hydraulic system reservoir was indicating just over half full. There was no evidence of fire around the right MLG.

Lower wing skin and flap fire damage

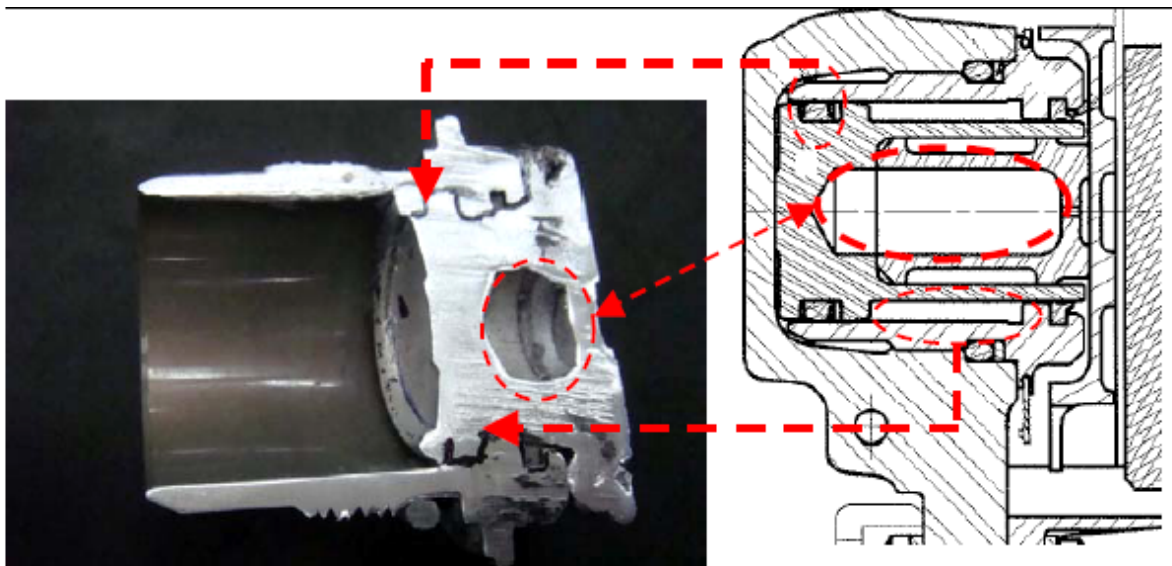
Figure 5

The inspection found that all three units displayed severe heat damage after experiencing 'exceptionally' high brake energies. The elastomeric static and dynamic piston seals were completely destroyed (seal degradation would have started at a temperature of 183°C). The aluminium alloy housings within the brake piston assembly had melted, indicating temperatures in excess of 200°C and the pistons themselves were significantly deformed (Figure 5). The protective coating on the carbon discs had been removed indicating temperatures in excess of 1,200°C.

Brake piston deformation
