G350™/G450™ (ATA 36): Amber Left Manifold Synoptic Line with APU Air Applied

By Al Lane, Customer Support Large-Cabin Mechanical Systems Group

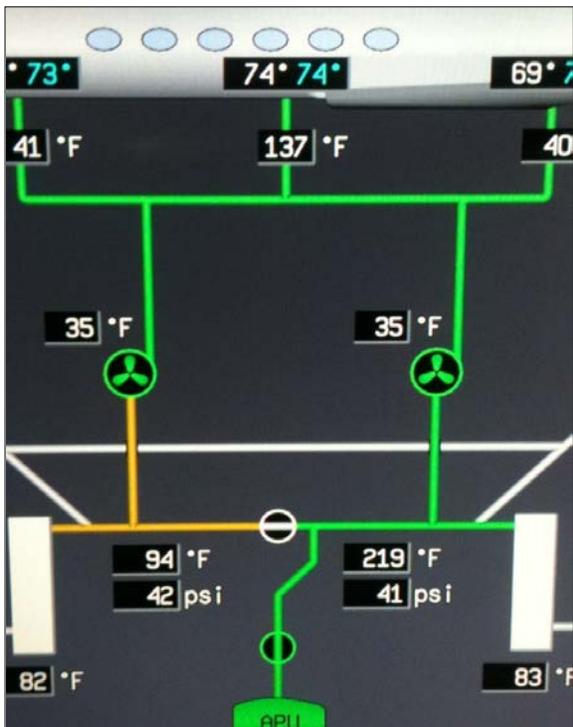
Since the precooler outlet temp on the left is farther from the dynamic airflow, the sensor in the left pylon ducting is cooler and will rarely reach 100°F during cold weather APU operations, and thus the synoptic page will display amber as designed until additional air flow is routed through the duct (LH engine bleed air). The right pylon ducting is closer to the APU duct, so it reaches 100°F or greater, which allows the synoptic line color to change to green.

APU bleed air selected during cold weather operations

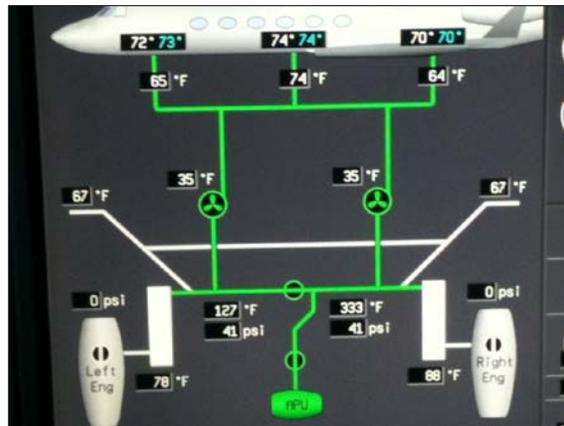
Normal engine bleed air selected during cold weather operations
