Tay 611-8C EEC Software Upgrade Program

ATA 71, Jeff Tome, 912-965-7303

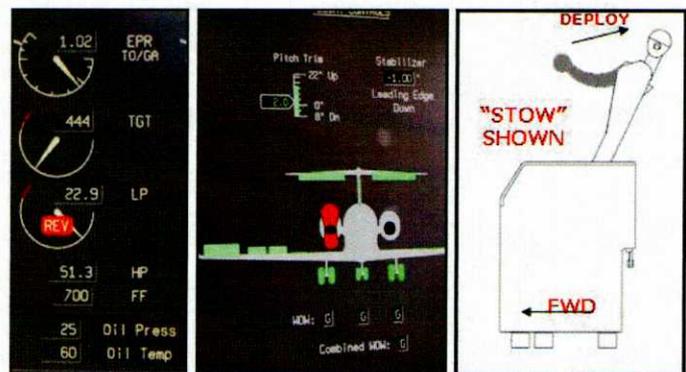
Figure 1

The red “REV” indication (see figure 1) on the LP RPM Gauge and a flashing “red reverser” (see figure 2) indication on the Flight Controls Synoptic (with no associated CAS message) may occur if the following two conditions in combination are met:

- Repeated deployment of the reversers in succession (deploy - stow - deploy) (see figure 3) with less than ten (10) seconds pause between the end of the “stow” and the start of the “deploy” cycle.
- Delay in the movement of the thrust reverser levers between the “stow” and “deploy” positions.

When this condition is encountered, idle to maximum reverse thrust is available but forward thrust is limited to idle power only.

The EEC believes it has detected a T/R inadvertent deploy due to a subtle difference in timing between the EEC and TRCU. The timing is unique to T5.1 software due to the use of microswitches in the TQA to initiate the deploy signal to the EEC. The condition

always allows continued use of the T/R's, but the affected engine is limited to idle thrust as a precaution against the hazardous condition it believes exists.

Gulfstream and Rolls-Royce are working on a permanent solution, but in the interim the following operational guidance is offered. When using the reversers during taxi to regulate taxi speed or when using the reversers to decelerate after landing, the movement of the reverse levers from forward thrust to the idle reverse detent or higher and back to forward thrust should be a crisp movement of the levers. Do not delay in either direction when moving the thrust reverse levers between stow and deploy positions. Intentionally delay approximately 10 seconds between thrust reverser “stow” command and the next “deploy” command.

Should the red “REV” icon in the LP RPM gauge and flashing “red reverser” indication on the Flight Controls Synoptic occur, the corrective action is to shut down the engine and to restart it. Once running, perform a normal thrust reverser check on the affected engine.
