## GII™- G550™ (ATA 27): FOD Prevents Flaps from Retracting to Full Up Position

By Customer Support Large-Cabin Mechanical Systems Group

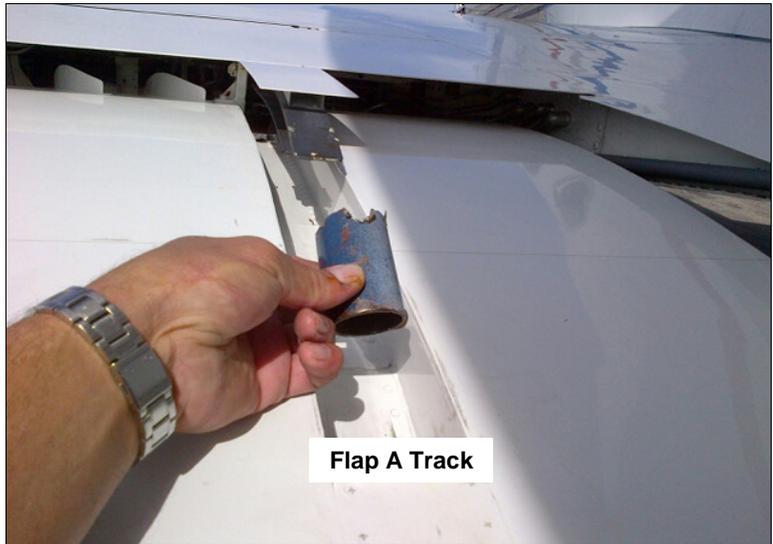
When the FSR arrived at the airport, the aircraft was already parked. He and the pilot inspected the flaps and found a piece of FOD inside the left flap "A" track well (see photograph). The FOD was removed, and the flaps were restored to normal operation with no CAS messages noted. The aircraft then continued on with the remainder of its missions. →

**FOD in the left Flap A Track prevented full up operation.**
