February 24, 2017

**The Gulfstream Journal**

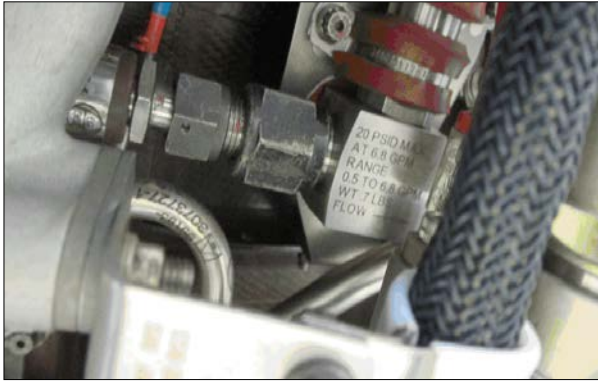
A few G150 aircraft have been experiencing erratic or failing fuel flow indications. Engineering has been investigating the issue and found that a key contributor is associated with over-torqueing of the AN818-8 nut during fuel flow transmitter installation, which could cause deformation of the fuel flow transmitter body. A deformation of the body will cause a turbulent flow due to damage in the internal turbine wheel and lead to intermittent or a complete loss of indication.

The initial investigation has found that access to the transmitter during replacement can be difficult, limiting the technician’s ability to obtain the required torque values. This article is intended to notify operators of the potential over-torque condition that likely occurs during installation. No safety concerns are being considered, as the issue is not linked to fuel line damage, but rather possible indication issues due to potential over-torqueing.

Fuel Flow Transmitter installation

As a result of this investigation, Gulfstream has updated the Aircraft Maintenance Manual (AMM) 73-31-01 Fuel Flow Transmitter — Removal / Installation procedure. The revision provides improved instructions during installation of the transmitter. Gulfstream also reminds operators to adhere to the torqueing requirements during installation. Ref. G150 AMM Revision 19 (February 15/17) and G100/SPX Advanced Information Notice (AIN) 73-30-01-ri for Revision 20 (May 30/17).

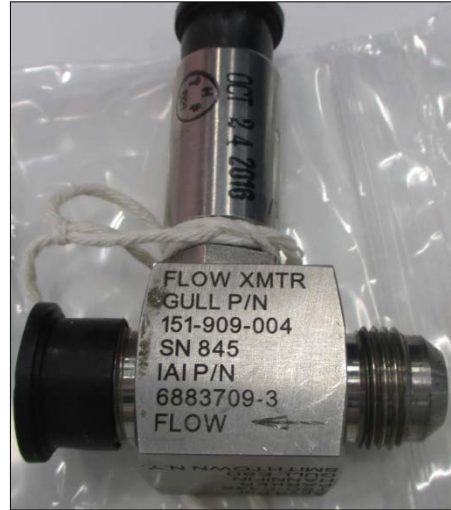
Fuel Flow Transmitter

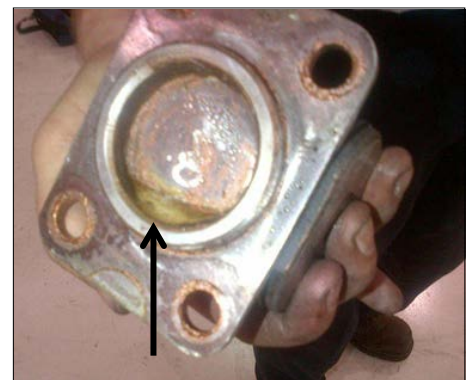
Gulfstream Service Centers have contacted Technical Operations, reporting water intrusion of the forward engine mount vibration isolators found during engine removals (see photos below). In some cases, corrosion was also noted at the engine's intermediate case assembly mount pad attach point.

Water noted at forward engine mount after removal

The Aircraft Maintenance Manual (AMM) 71-00-00 Powerplant — Removal / Installation procedure also requires removal and inspection of the forward engine mounts per AMM 71-20-00 Engine Isolator / Resilient Mount — Detailed Inspection. To address possible water intrusion and corrosion of the upper and lower forward engine mount attach points, Gulfstream incorporated an additional corrosion preventative compound application during re-installation of the forward engine mount vibration isolators during powerplant installation. This additional protection between the magnesium outer engine case and corrosion resistant steel mount was incorporated into the AMM 71-20-06 Forward Engine Mount Vibration Isolator — Removal / Installation procedure, adding a primer/topcoat or Hylomar coating at the isolator and engine interface.

If corrosion is noted at the engine's intermediate case assembly attach point, operators can use the revised procedures in the Engine Maintenance Manual (EMM) for repair. EMM 72-30-01 was updated to add inspection criteria, corrosion damage limits, and repair of the intermediate case assembly mount pads. In rare cases where corrosion of the mount pads is beyond EMM limits, contact Gulfstream Customer Support. →

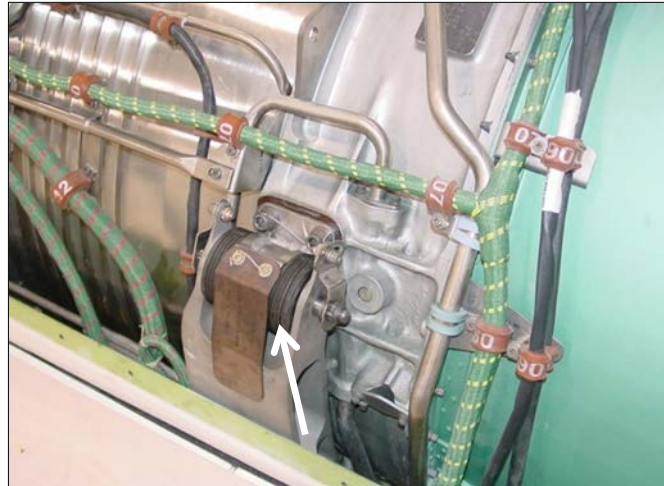
Arrow points to upper forward engine mount vibration isolator

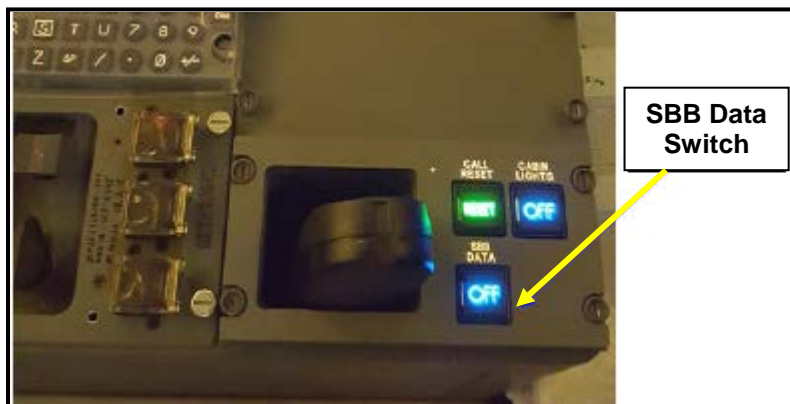
The SBB data switch is located in the cockpit pedestal's Optional Switch Panel (reference Figure 1). Additional wiring will be added along an existing wire routing from the pedestal, around the cockpit to a switching node at the right mid-cabin area. When the switch is activated, the switch will annunciate OFF in blue and customer data transmissions will be disabled. When the switch is deactivated, the annunciator will extinguish and the customer data transmissions will resume.

Figure 1 - Location of the SBB Switch in the Optional Switch Panel on the center pedestal

For in-service aircraft, modification of the Optional Switch Panel requires a new lighted overlay, and internal structural modifications to accommodate the SBB data switch. Quoting for the install and coordination with a Gulfstream Service Center should be done in advance to make sure parts will be available during the service visit. →
