**SUBJ:** FMS and GPS Equipment Advisory Vertical Guidance with no  
Published Vertical Descent Angle

**SAIB:** HQ-14-25  
**Date:** August 26, 2014

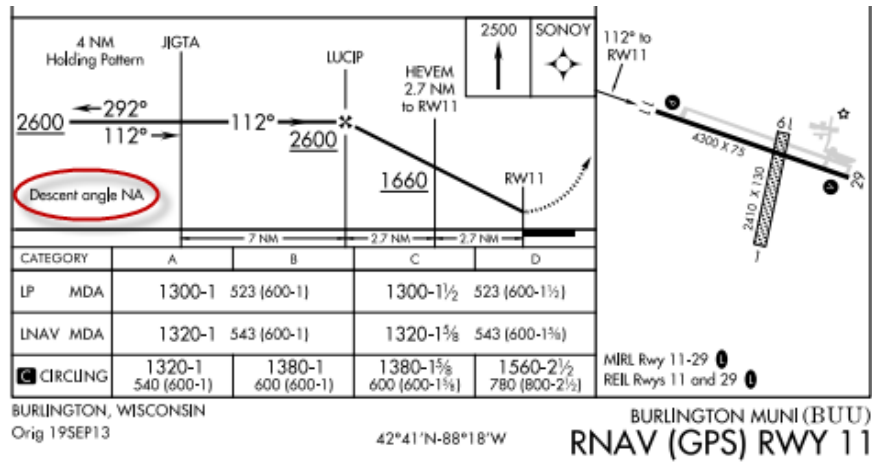
When the FAA charts these IAPs, they do not show a vertical descent angle in the profile view.

The charts currently include the following statement: “**Descent Angle NA**”. Like flying any other IAP, the pilot must see and avoid any obstacles in the visual segment during transition to landing.

The affected IAPs may create a hazard if the pilot continued to reference the advisory vertical guidance while transitioning to the visual segment of the approach. To avoid creating a possible hazard, FAA procedure designers began excluding a vertical descent angle from these IAPs and coding a “0” (zero) in the appropriate ARINC 424 database format specifications to communicate the absence of the vertical descent angle.

The FAA recommends operators and pilots carefully review departure, destination and alternate airport IAPs during pre-flight operations. During this review, operators and pilots should look for IAPs published with no vertical descent angle and charted with the statement: “**Descent Angle NA**” or “**Descent Angle NA – Obstacles**” in the profile view of the procedure. For these IAPs, the FAA recommends finding and planning to use another IAP (if available) not affected by this airworthiness concern.
