ICE CRYSTAL ICING & HOT TOWERS

John Salamankas

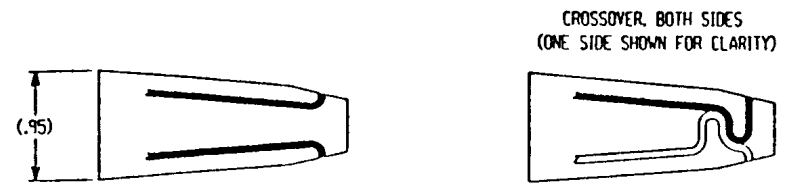
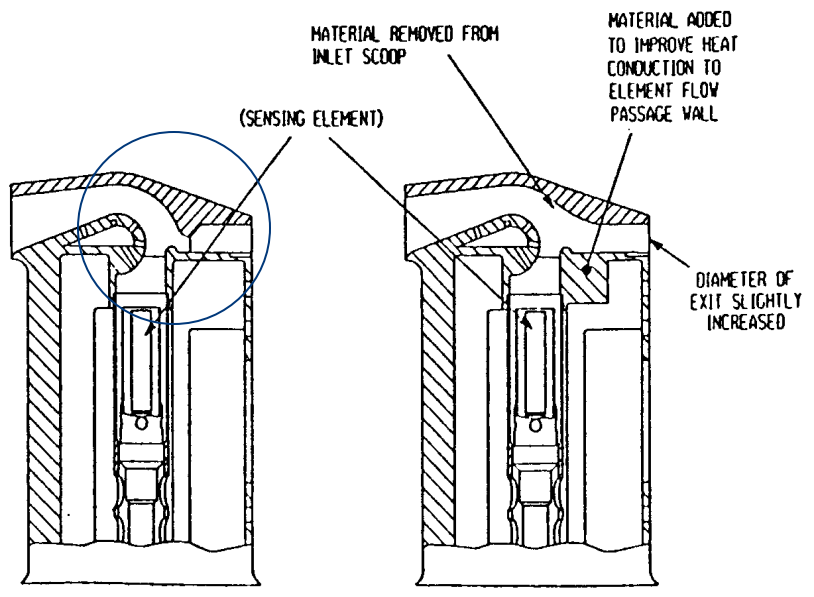
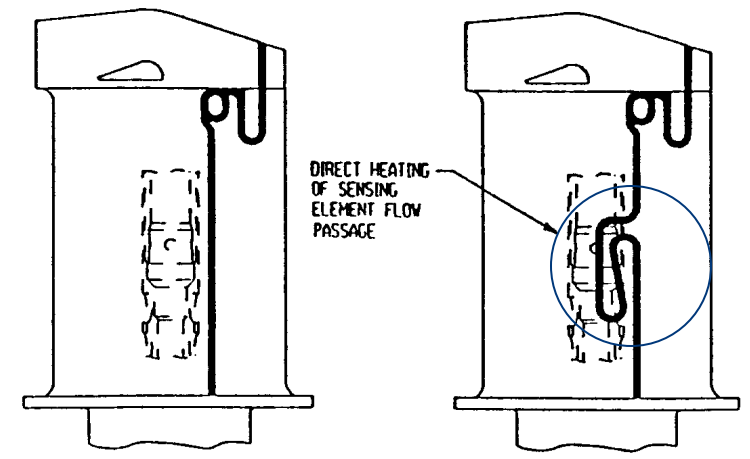
Probe Enhancements

- **Review of sensor specs and fault history**
 - High MTBR
 - 60% heater failures, 2% sensor failures
- **Part Number change for PlaneView aircraft**
 - Performance enhanced in extreme icing conditions
 - Inlet scoop change to reduce *clogging by ice crystals*
 - Improved internal heat conduction to critical surfaces
 - Increased heater power
- **No Hot Tower reports from PlaneView aircraft**
