ICE CRYSTAL ICING & HOT TOWERS

John Salamankas

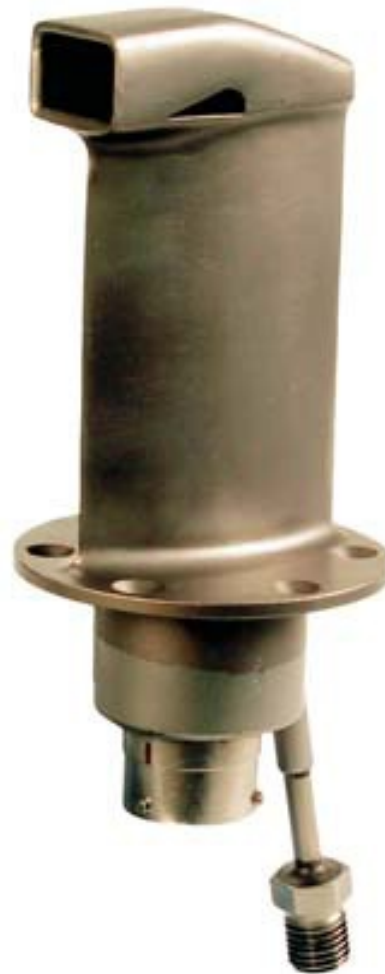
Hot Towers or Not Goodrich Total Temp Probe

- **Temp rise *assumed* due to hot tower**
 - Is the indication correct?
 - Could there be another cause?
- **Focus on Total Temperature Sensor**
 - Gulfstream probes same as Boeing & many others
 - Identical externally
 - Minor internal variations by PN
 - Heater current type
 - Base plate contour
 - Connector type
