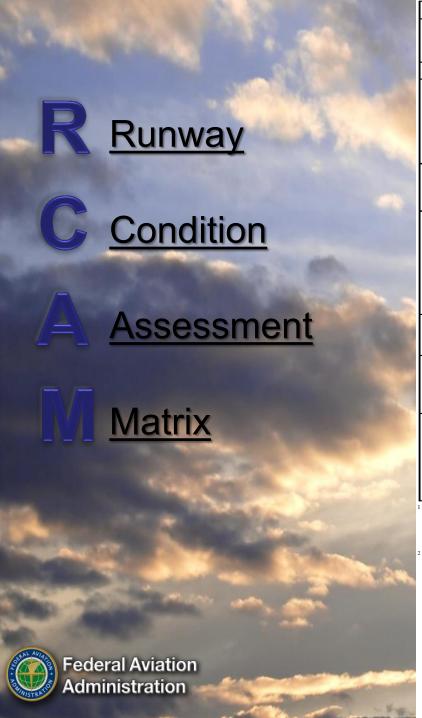
Assessment Criteria			Downgrade Assessment Criteria			
Runway Condition Description	Code	Mu	Mu (μ) ¹		Vehicle Deceleration or Directional Control Observation	Pilot Reported Braking Action

• Dry	6		Г	7		
 Frost Wet (Includes Damp and 1/8 inch depth or less of water) 1/8 inch (3mm) depth or less of: Slush Dry Snow Wet Snow 	5		10 01 11191101	40 or Higher 29 1	Braking deceleration is normal for the wheel braking effort applied AND directional control is normal.	Good
5° F (-15°C) and Colder outside air temperature: • Compacted Snow	4	39	L		Braking deceleration OR directional control is between Good and Medium.	Good to Medium
Slippery When Wet (wet runway) Dry Snow or Wet Snow (Any depth) over Compacted Snow Greater than 1/8 inch (3mm) depth of: Dry Snow Wet Snow Warmer than 5° F (-15°C) outside air temperature: Compacted Snow	3	to 30			Braking deceleration is noticeably reduced for the wheel braking effort applied OR directional control is noticeably reduced.	Medium
Greater than 1/8 (3mm) inch depth of: Water Slush	2				Braking deceleration OR directional control is between Medium and Poor.	Medium to Poor

• Ice ²	1			to 21	Braking deceleration is significantly reduced for the wheel braking effort applied OR directional control is significantly reduced.	Poor
Wet Ice ² Slush over Ice Water over Compacted Snow ² Dry Snow or Wet Snow over Ice ²	0	20 or Lower	L		Braking deceleration is minimal to non-existent for the wheel braking effort applied OR directional control is uncertain.	Nil
The correlation of the Mu (μ) values with runway conditions and condit friction measuring device and are intended to be used only to downg identified in Note 2. Airport operators should use their best judgment	rade a rui	nway	con	dit	ion code; with the exception of	circumstances
